Navajo Abandoned Uranium Mine

Site Screen Report

Mine Name: Jimmie Boone
Mine ID: 91

August 2011

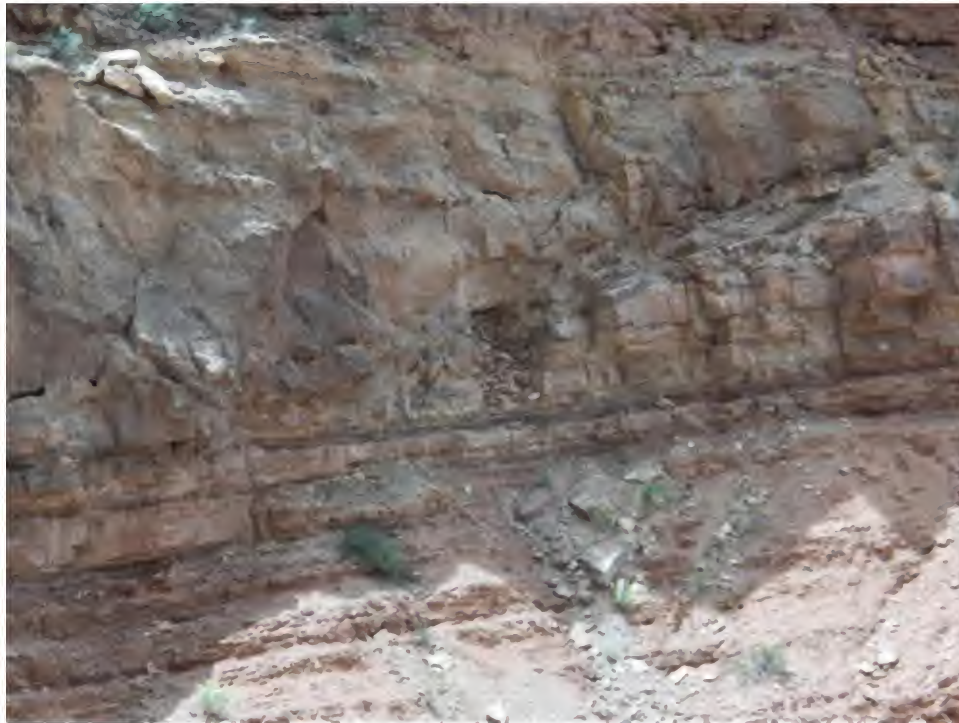
Photo 3: Mine Site #91; Possible adit

4 adits: Adit 1 - brick sealed, N side of canyon wall; Adit 2 - brick sealed, S side of canyon wall; Adit 3 - open, upon cliff on N wall; Adit 4 - possible adit above sealed adit on N canyon wall (Adit 1)

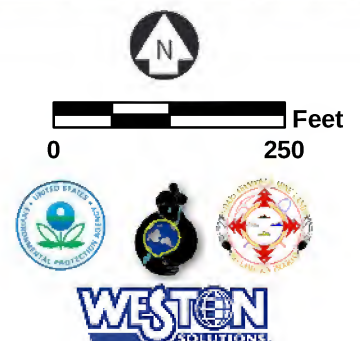
**Figure 1 - Gamma Radiation Measurements, Above Two Times Background
Jimmie Boone (91)
Bodaway / Gap Chapter, Navajo Nation**

Average background 12,338 cpm

A total of 2,972 gamma radiation measurements were collected from the mine site, ranging from 7,957 cpm to 94,571 cpm. Measurements collected in the vicinity of the waste rock were found at a maximum level of approximately 95,000 cpm. The measurements are represented in Figures 1 and 2.

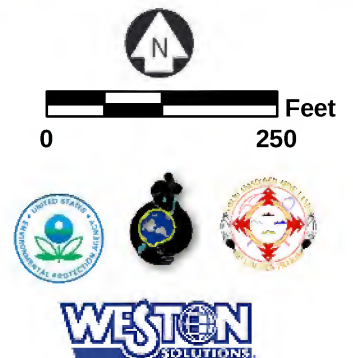
Figure 2 - Gamma Radiation Measurements
Jimmie Boone (91)
Bodaway / Gap Chapter, Navajo Nation

Measured as counts per minute (cpm)
 Average background 12,338 cpm
